GEORGIA'S OLD FEDERAL ROAD

PHASE II: DEVELOPMENT OF A TECHNICAL CONTEXT FOR THE FEDERAL ROAD IN NORTH GEORGIA

By
The Center for Archaeological Research
Department of Sociology and Anthropology
University of Mississippi
2006

**Final Report
Georgia Department of Transportation Project No. 05-07**

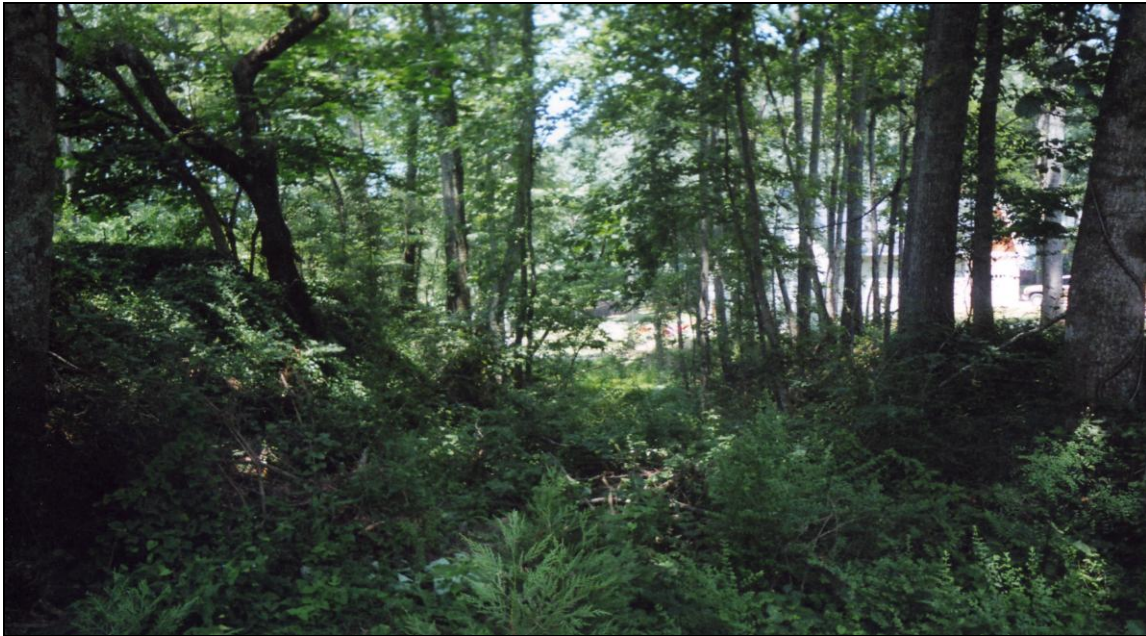
Figure 3. Photo of Reference Point 1, an Intact Segment along Little Mill Road (facing west; hyperlinked in GIS database).

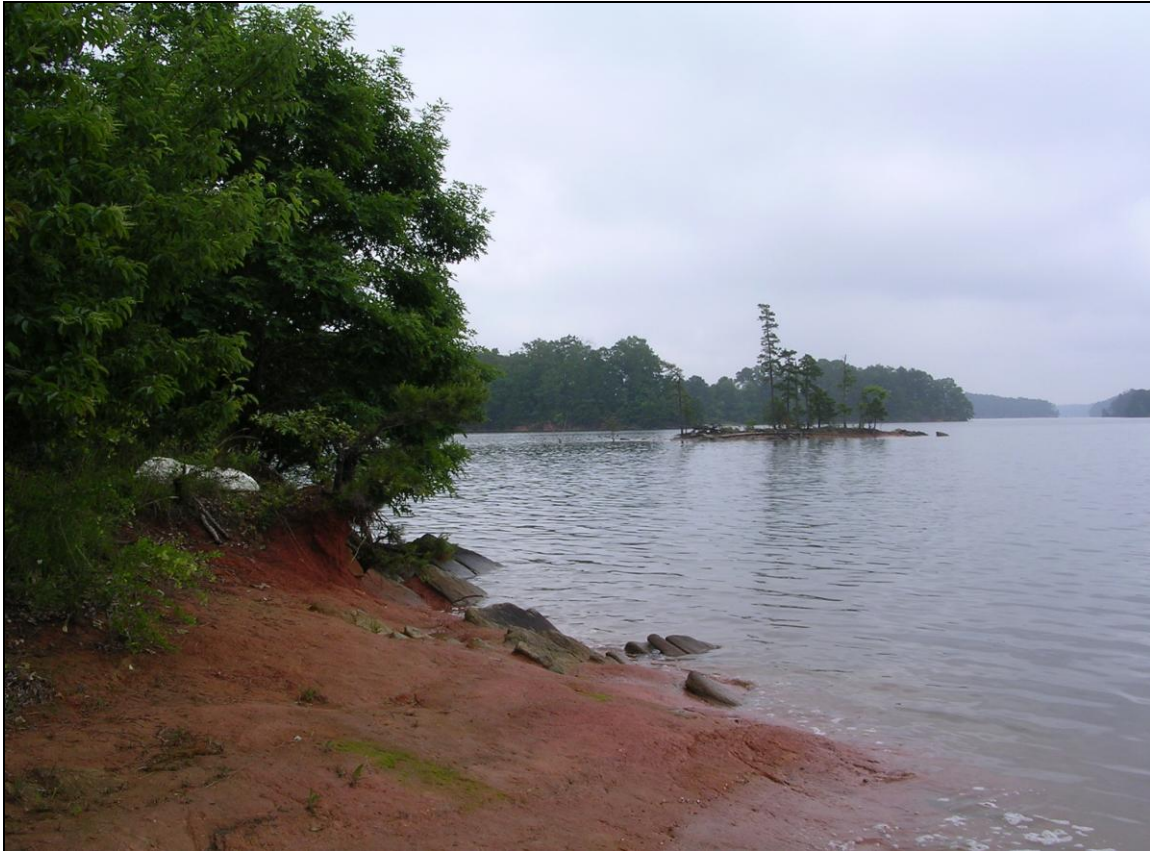
The northern crossing, indicated as Winn's Ferry on the 1832 map is currently under Lake Lanier. It is not included in the GIS database (Figure 4). At UTM coordinate N3792743 E779240 (Reference Point 2 in Figure 1 and Figure 5) there is an impressive 600 m stretch of entrenched roadway along the north side of the ridge that coincides with a road indicated on the USGS quadrangle. This road is no longer actively used. It is probable that this was an access road to the Winn's Ferry crossing point. Here,

Figure 4. Photo of the Terminus of an Intact Segment at the Shore of Lake Lanier (facing east; not hyperlinked in GIS database).

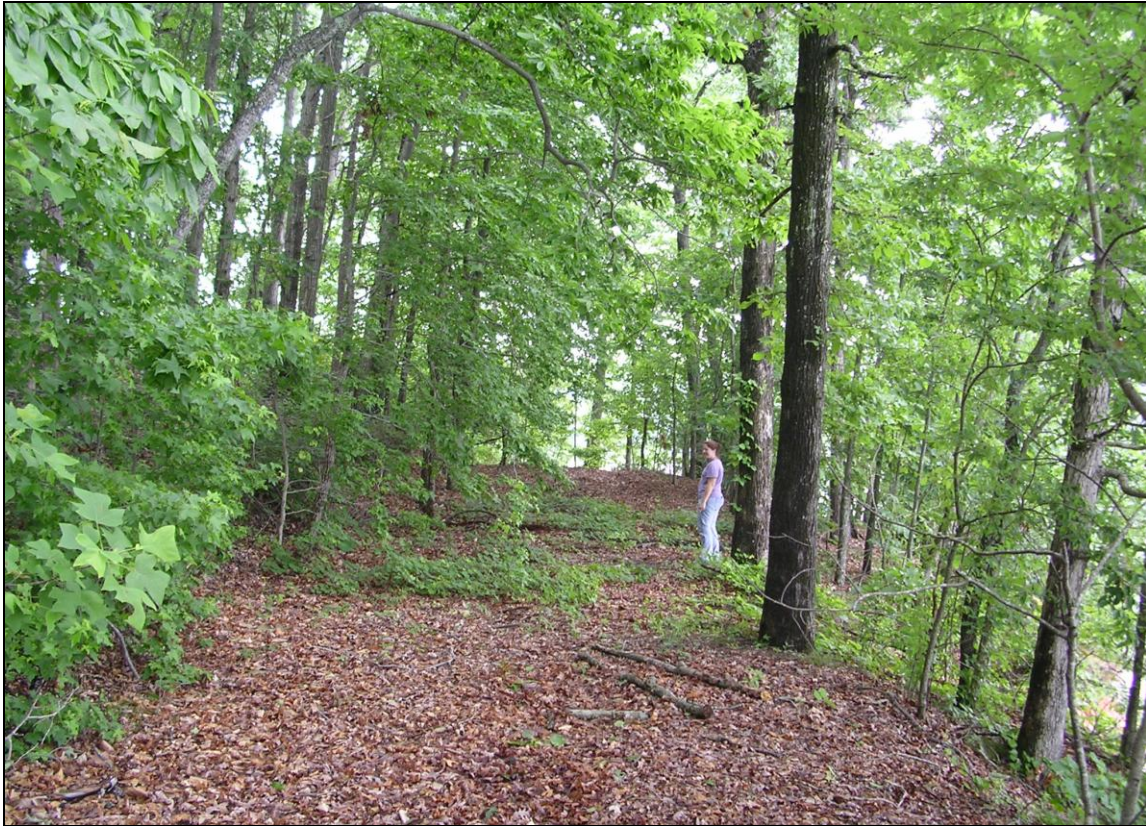
Figure 5. Photo of Reference Point 2, an Intact Segment along Lake Lanier (facing west; hyperlinked in GIS database).

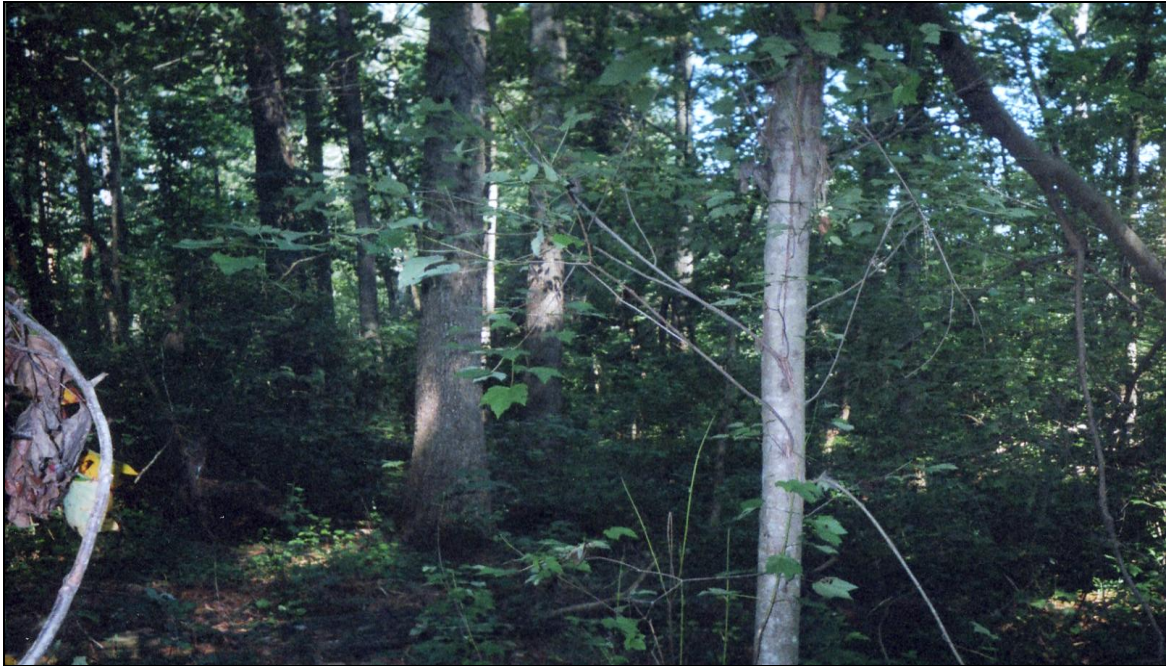
Figure 6. Photo of Reference Point 4, an Intact Segment East of Fort Campbell (facing east; hyperlinked in GIS database).

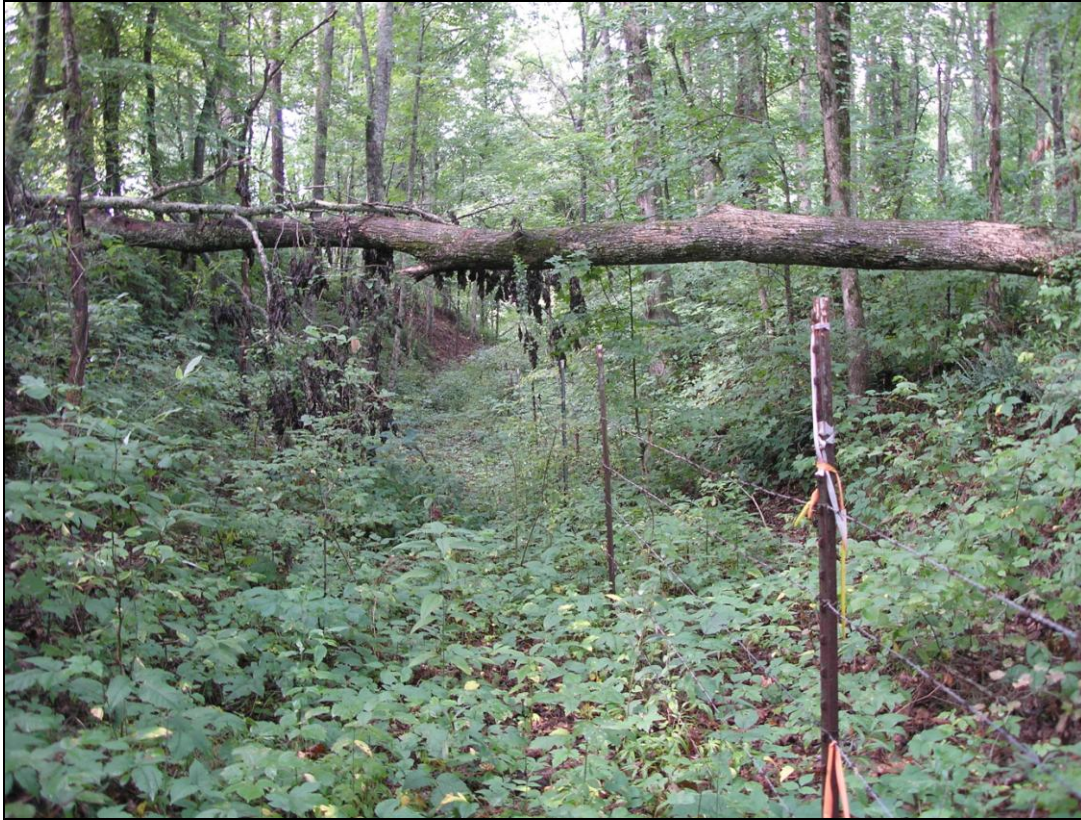
There is an entrenched segment of roadbed located at approximately N3799891 E756790, east of Mount Tabor Road in Forsyth County, and extending approximately 100 m in a southwesterly direction (Figure 7). At the time of survey we were unable to trace this segment to its full extent through the woods. Our suspicion is that this segment links up with the segment described in the previous paragraph.

Figure 7. Photo of an Entrenched Segment of Roadbed Located East of Mount Tabor Road in Forsyth County (facing south; not hyperlinked in GIS database).

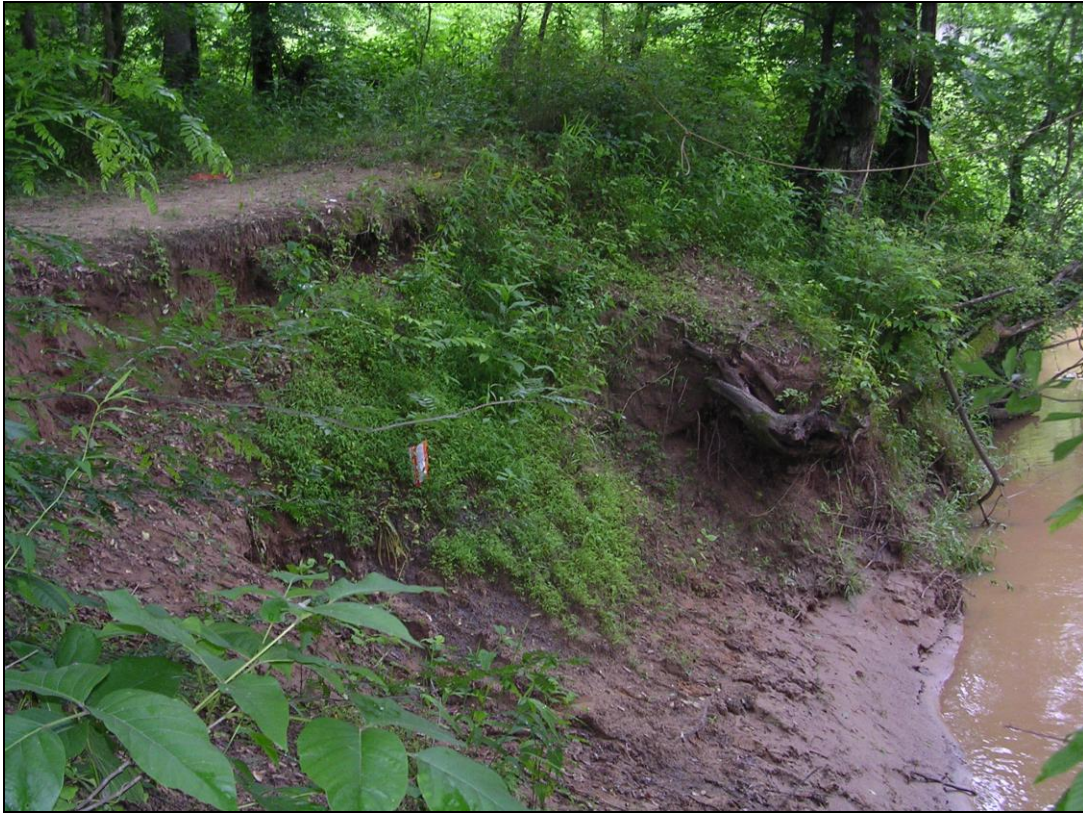
Further west from Fort Campbell, the GIS-reconstructed road crosses the Etowah River (Figure 8). The reconstructed crossing point is located between 20 m and 50 m north, upstream of the existing

crossing point. With an examination of this location, the field crew found no indication of the historic road crossing. The cut bank here indicated considerable recent alluvial deposition, which would have obscured any trace of the old road.

Figure 8. Photo of Reconstructed-Route Crossing at the Etowah River (facing east; hyperlinked in GIS database).

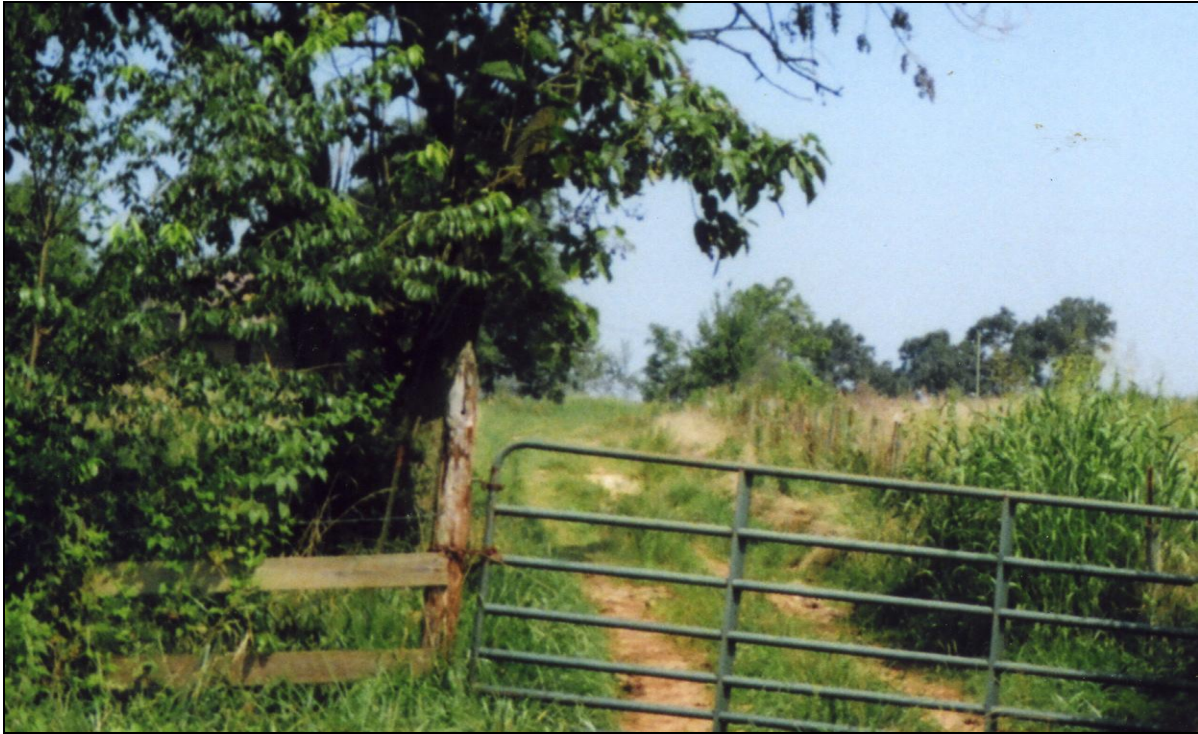
Figure 9. Photo of Reference Point 5, an Intact Segment Used as a Farm Road (facing north; hyperlinked in GIS database).

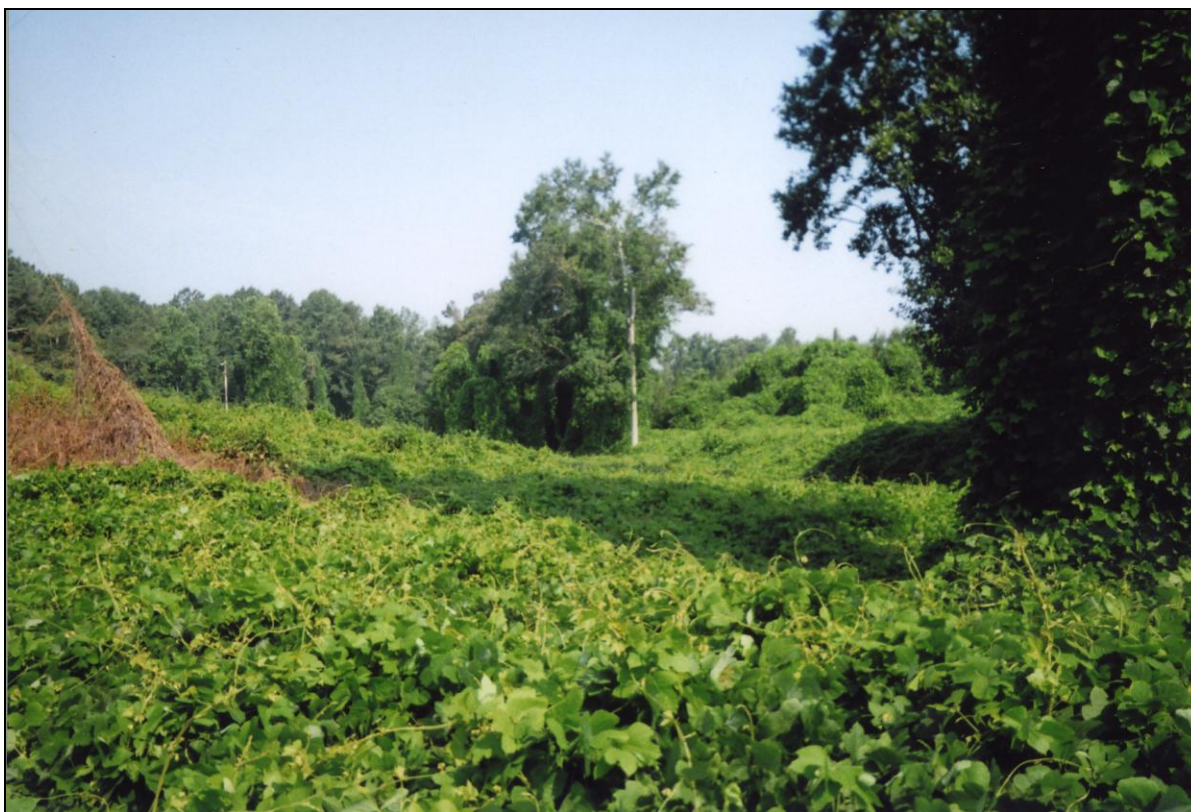
Figure 10. Dense Vegetation East of Ophir, Georgia (facing north; hyperlinked in GIS database).

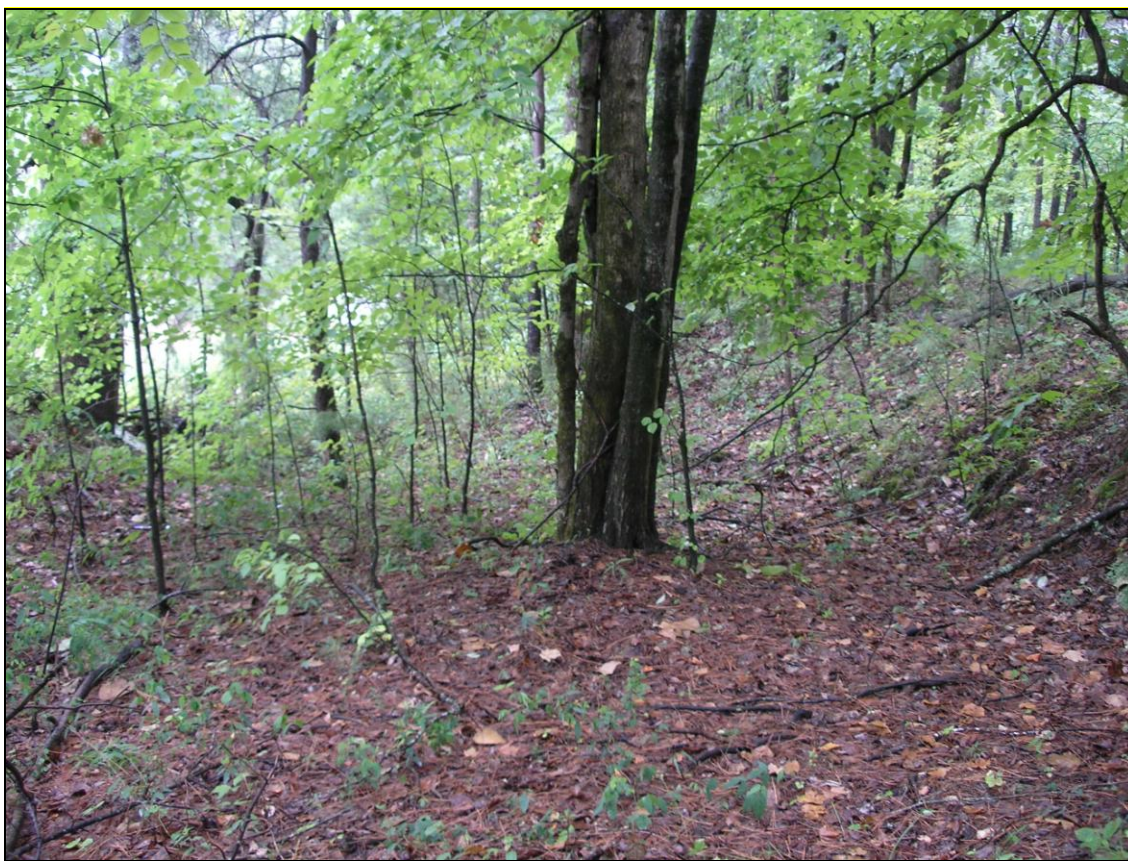
Field inspection of the southern (1903) route revealed the presence of entrenched roadbed to the south of existing Lawson Federal Road, at approximately N3807948 E748603 (Figure 12). This segment is 40 m long, and 5 m across at the base. It is entrenched 2 to 3 m below the existing ground surface. It trends northwest/southeast, parallel to the existing Lawson Federal Road. Archaeological integrity at this

Figure 12. Photo of an Entrenched Roadbed at Approximately N3807948 E748603 (facing east; hyperlinked in GIS database).

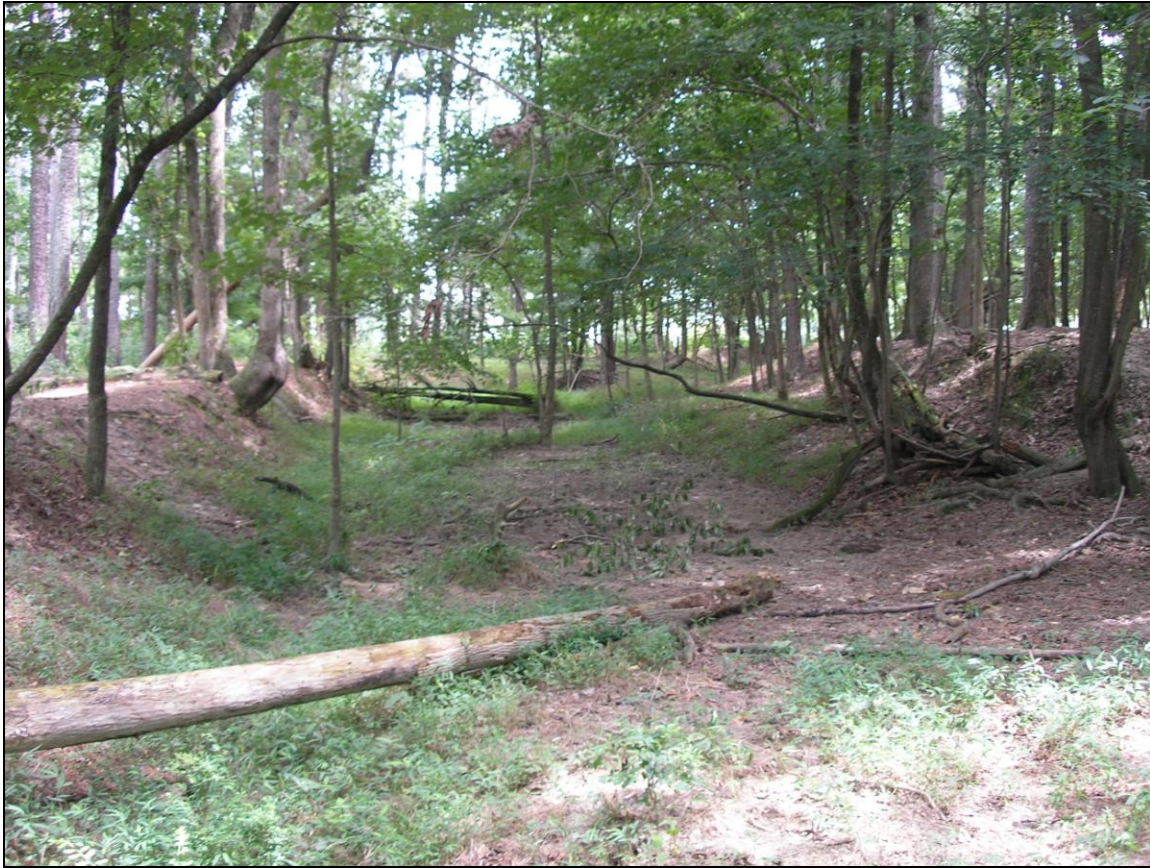
Continuing northwest, the GIS-reconstructed route crosses to the north of Old SR 5 to drop into the valley of an intermittent tributary to Talking Rock Creek. The old route in this location has been maintained as a residential street. Toward the town of Talking Rock, the modern road keeps to the south side of Talking Rock Creek, while the reconstructed road crosses near the confluence with Mill Creek. However, the field crew saw no sign of the old road in this bottomland area. Approximately 1.3 km northwest of the town of Talking Rock, a small segment of intact roadbed is visible behind a cemetery known as the Darnell Cemetery (interments date primarily to the twentieth century). This segment is located at N3822090 E727852 and is 110 m long (Figure 15). This segment has only fair to poor

archaeological integrity. The segment is within a wooded section of a pasture and has suffered significant erosion. Additionally, the segment has been damaged by construction of drainage culverts. The historical integrity of this location is also only fair to poor. The western end of the segment has been truncated by the construction of SR 5/515, and there is considerable noise pollution from this road.

Figure 15. A Small Segment of Intact Roadbed behind Darnell Cemetery (facing east; hyperlinked in GIS database).

8) The eighth section is a 110 m intact section northwest of the town of Talking Rock and behind Darnell Cemetery (see Figures 13 and 15; also see the discussion in Chapter 3, Segment 3). It is in a wooded patch in a pasture but has significant erosion, and it has also been damaged by the construction of drainage culverts. There is also considerable noise pollution from nearby SR 5/515. Therefore, the historical and archaeological integrity is only fair to poor.

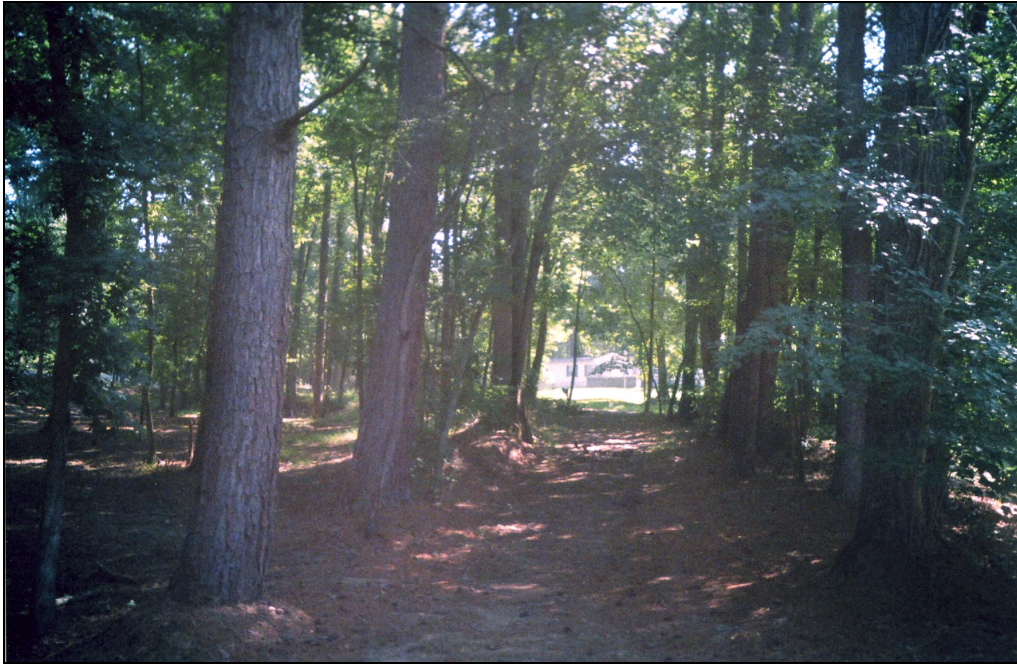
Figure 16. Photo of Reference Point 16, an Intact Segment near Fort Newnan and Blaine, Georgia (facing west; hyperlinked in GIS database).

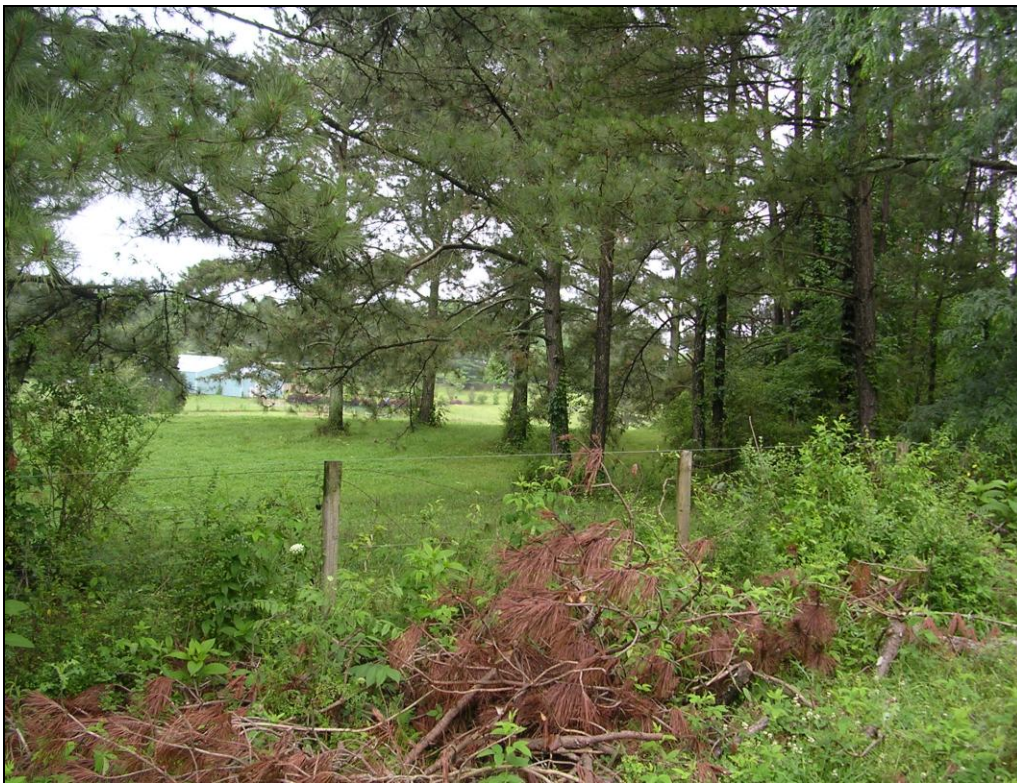
Figure 17. Photo of Reference Point 17, an Intact Segment West of Blaine, Georgia (facing south; hyperlinked in GIS database).

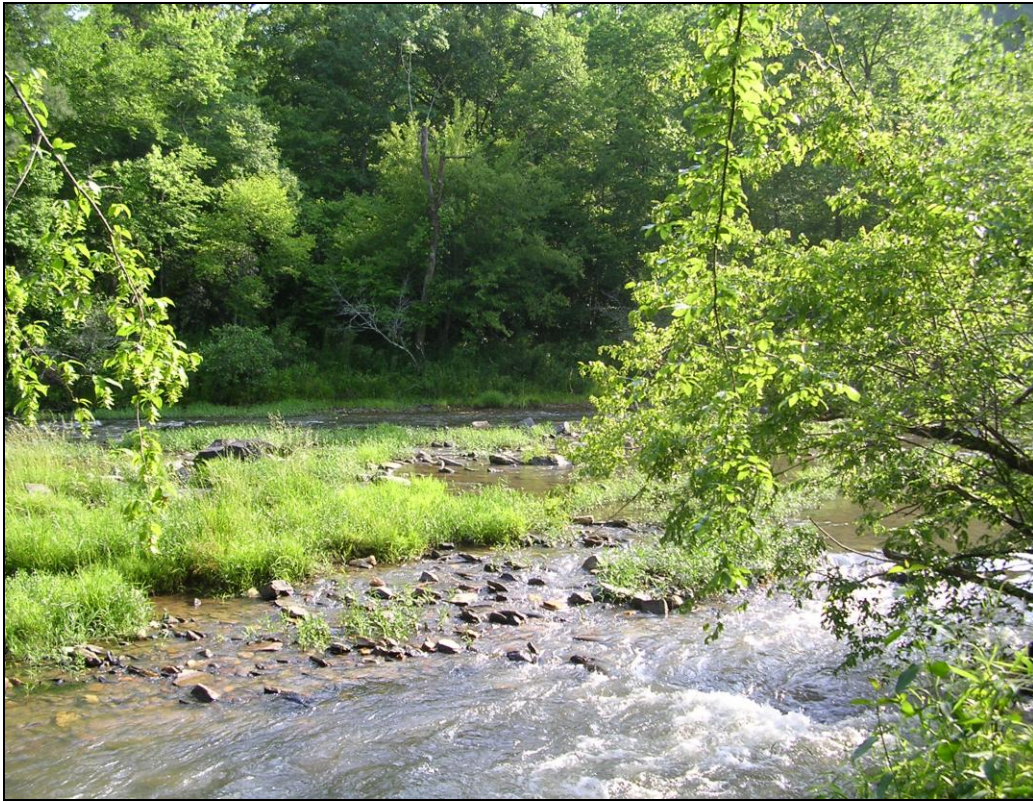
Figure 18. Photo of Possible Ford at Talking Rock Creek (facing north; hyperlinked in GIS database).

11) This section begins at the northern bank of Talking Rock Creek and extends for approximately 240 m north (see Figures 14 and 18; also see the discussion in Chapter 3, Segment 3). The road begins at a shallow location in the creek, about 50 m downstream of the modern bridge on SR 136. Historic integrity is good in this location, as little development is evident. However, we were unable to assess the physical integrity of the roadbed, and we recommend additional study to verify whether or not it is truly part of the 1832 road.

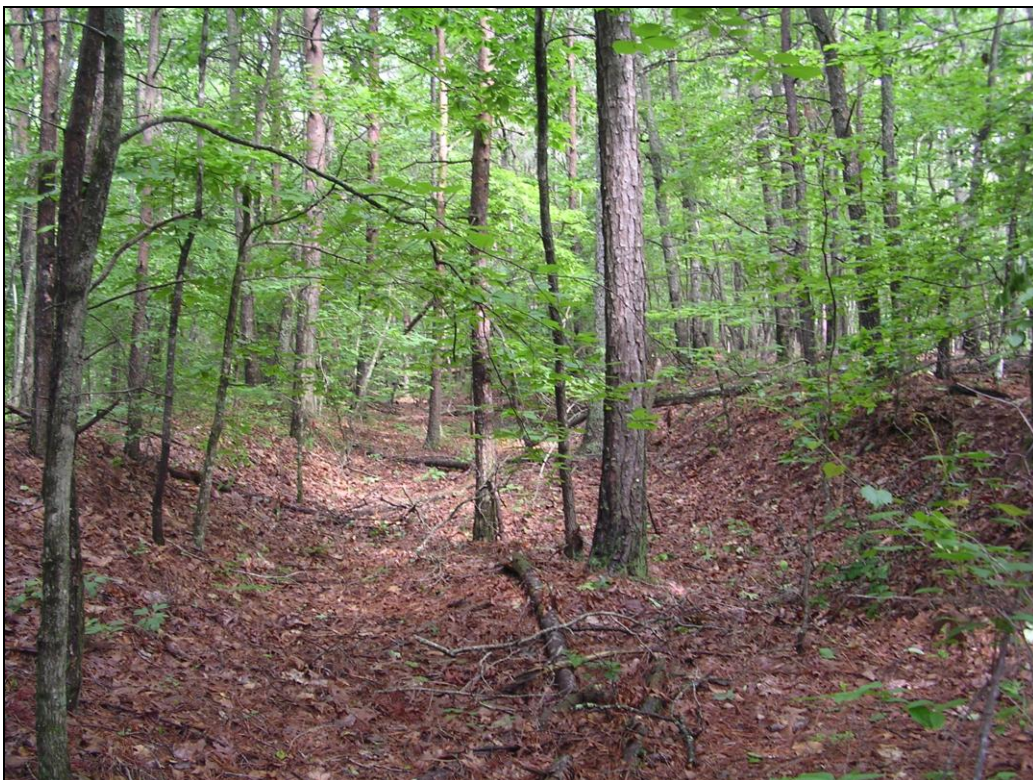
Figure 19. Photo of an Intact Segment North of SR 136 (facing west; hyperlinked in GIS database).

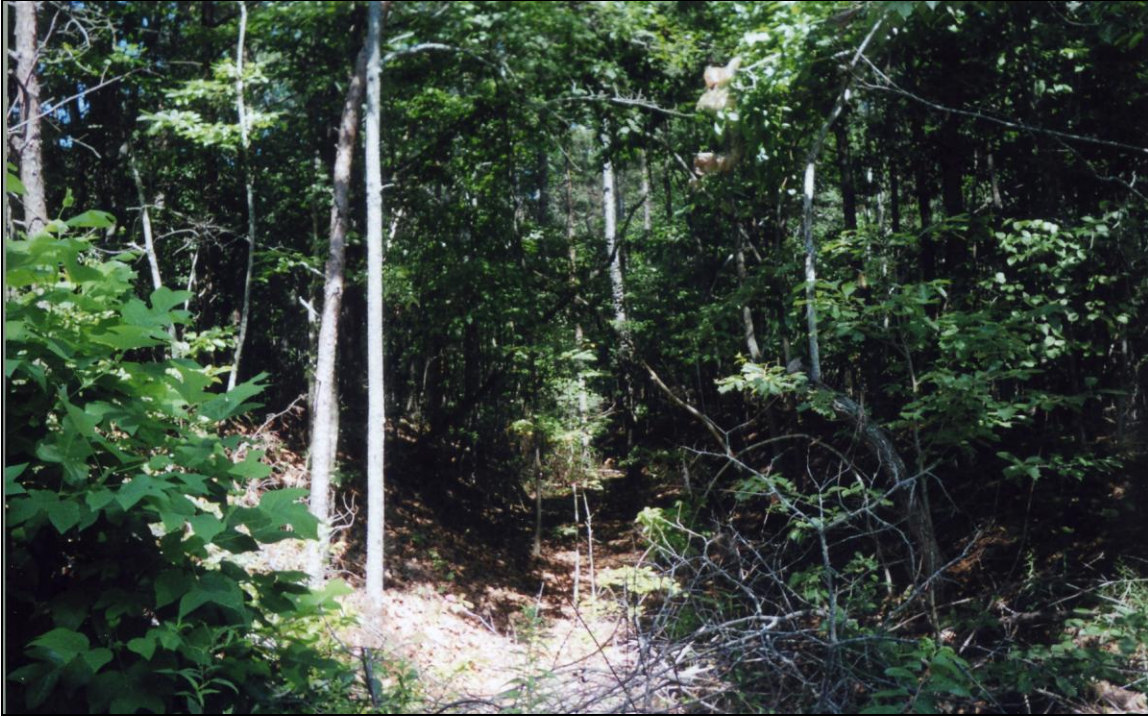
Figure 20. Photo of an Intact Segment North of SR 136 (facing west; hyperlinked in GIS database).

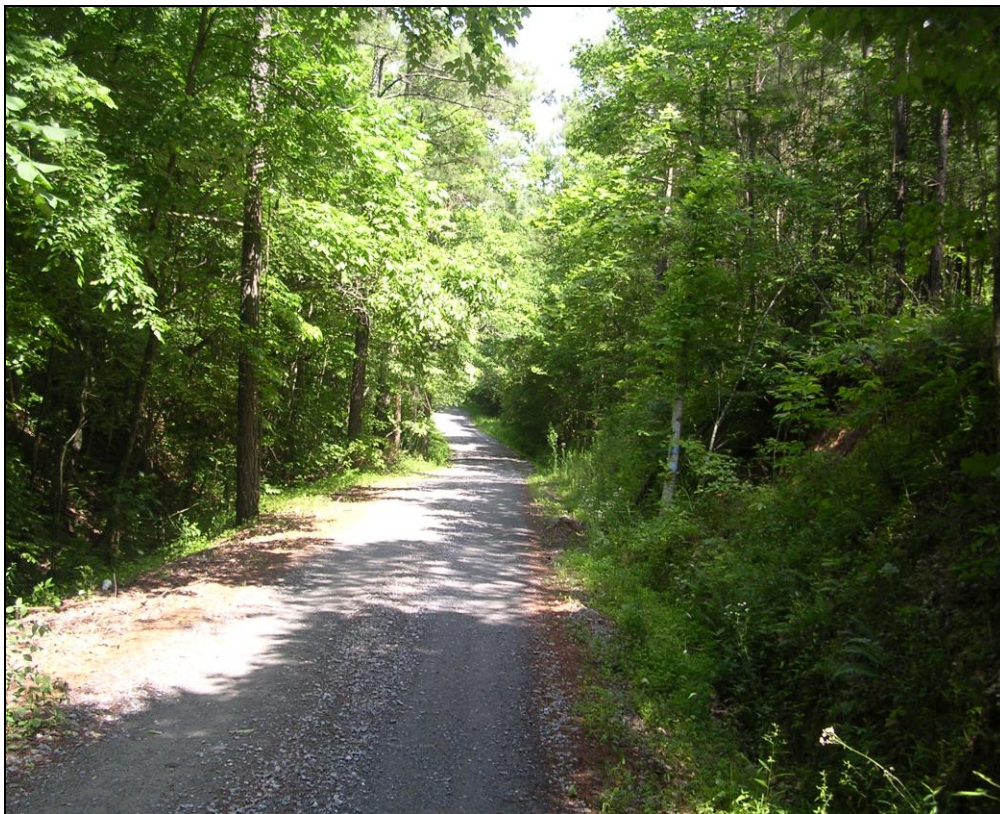
Figure 21. Photo of the Shady Grove Baptist Church Access Road (facing south; hyperlinked in GIS database).

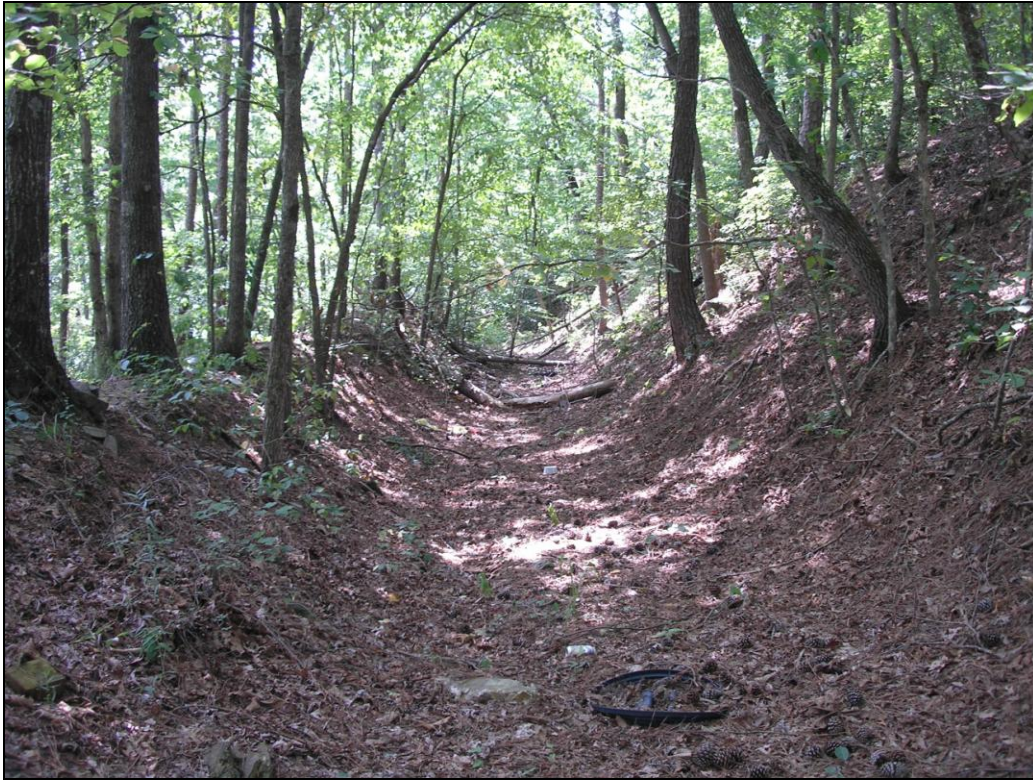
nearly 90 degree turn toward the west. The road then followed the ridge as it dropped down. An intact portion of entrenched roadbed is visible south of the church parking lot (Figure 22; see Figure 14). This segment is approximately 300 m long. The northern side of the road is entrenched approximately 3 meters, but this is exaggerated by the slope of the land. The southern bank of the road is only 1.5 m below the ground surface. The roadbed itself is approximately 3 m wide at the base. The archaeological integrity of this location is excellent. The historical integrity is, however, only fair. The eastern 100 m of the marked segment has been used as a garbage dump, and is visually unattractive, to say the least. Further west, there is less garbage on the ground. At the time of survey only the eastern 300 m of the feature was accessible. The USGS quadrangle map indicates a dotted line extending further west from this location. This dotted line eventually links up with SR 136 near the location predicted by the GIS reconstruction.

Figure 22. Photo of an Intact Segment South of the Shady Grove Baptist Church (facing west; hyperlinked in the GIS database).

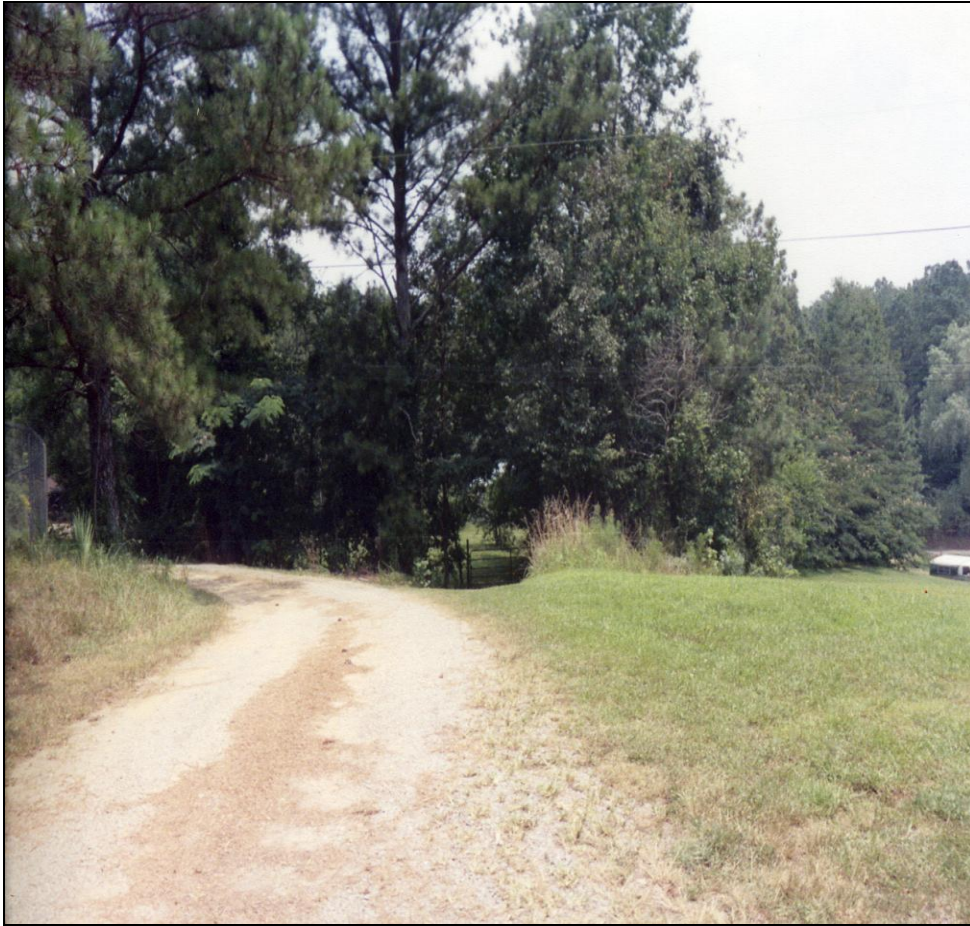
The reconstructed route then runs approximately 1.3 km north along an existing roadway toward Lakeview Church. Here a small segment of intact road is visible in a yard at N3852346 E704133 (Reference Point 27 in Figure 24). This segment is approximately 110 m long and 3 m wide. It does not appear endangered at this time, but its location within a residential area compromises any historical integrity (Figure 26).

Figure 26. Photo of Reference Point 27, an Intact Segment in a Residential Area (facing north; hyperlinked in GIS database).

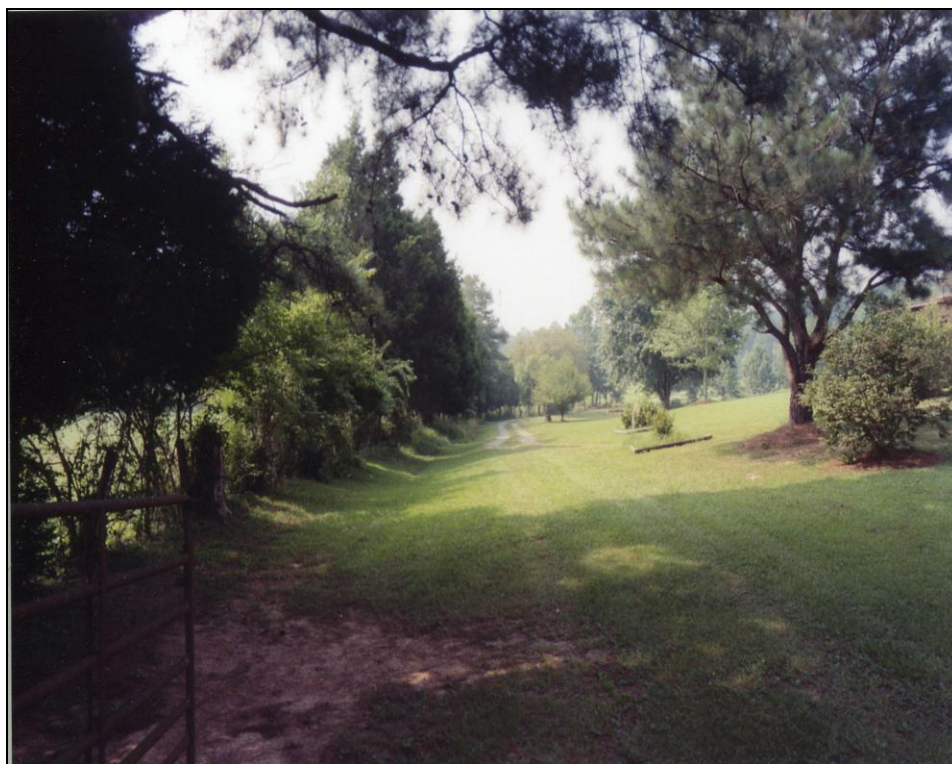
Figure 27. Photo of Reference Point 30, a Possible Intact Segment in an Existing Field Road (facing north; hyperlinked in GIS database).

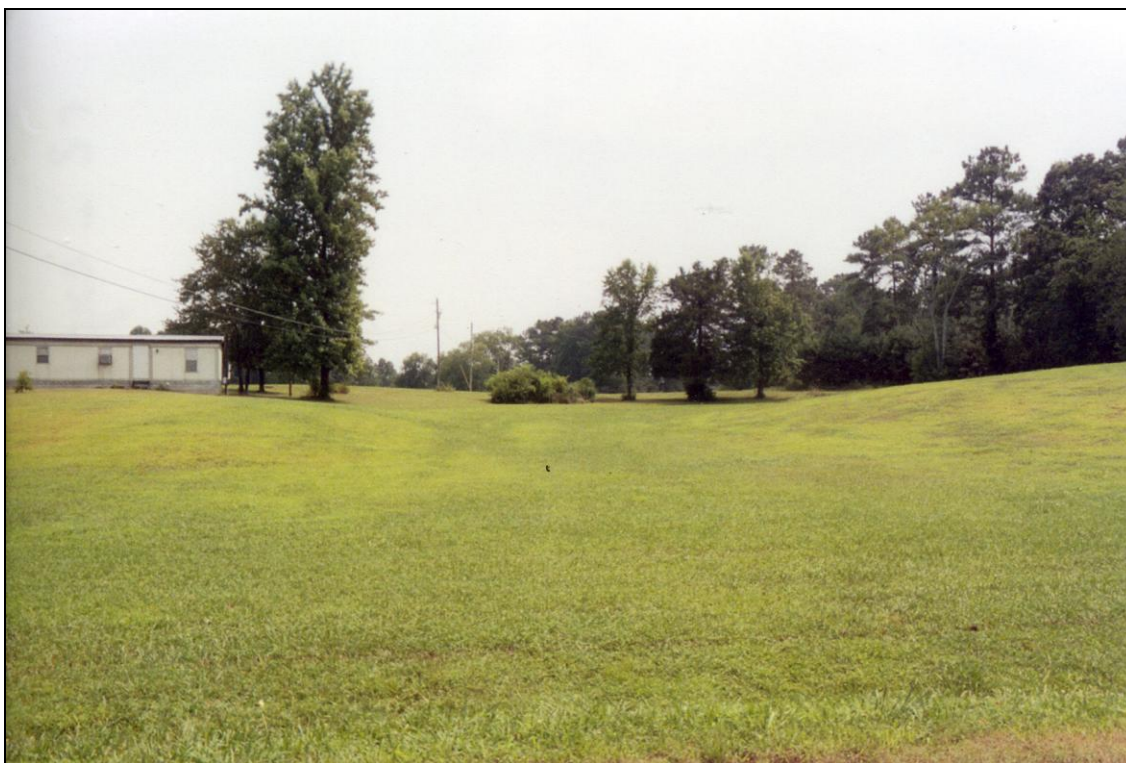
Figure 30. Photo of Reference Point 36, an Intact Segment in a Residential Area (facing north; hyperlinked in GIS database).

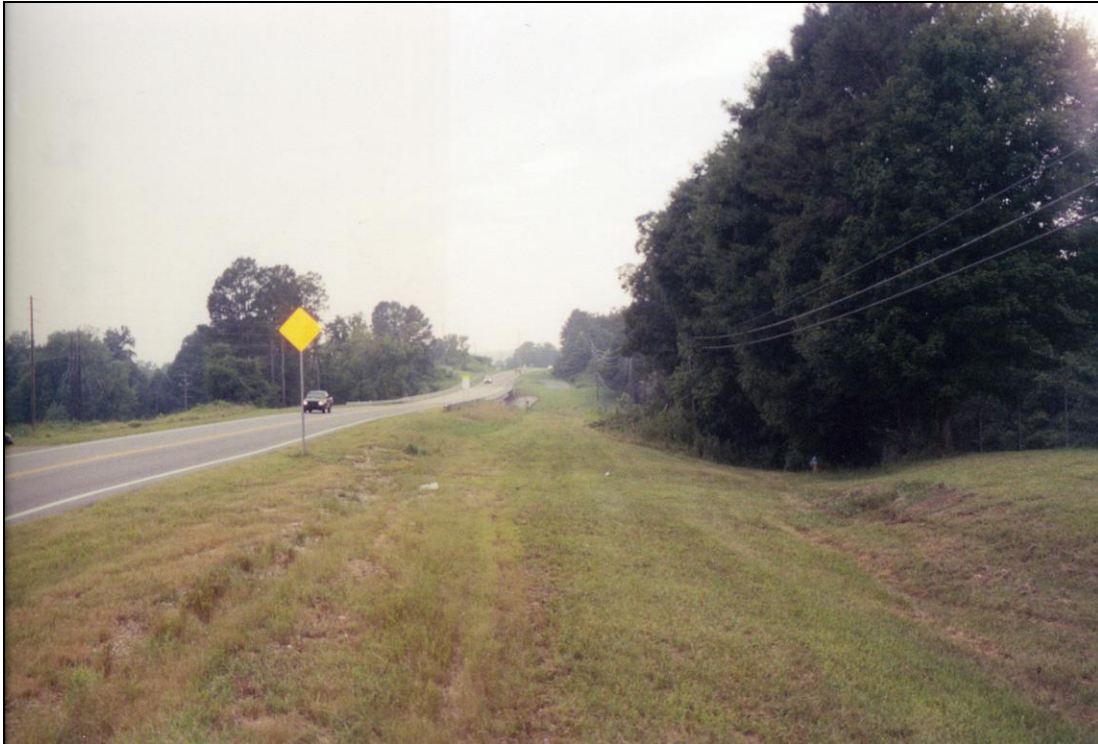
Figure 33. Photo of an Intact Segment Parallel to an Existing Right-of-Way (facing west; hyperlinked in GIS database).
